## Tech: Testing VSWR Pro Mods

### Modifications to the VSWR Protection Board

Edited 11/04/2017 1:30pm

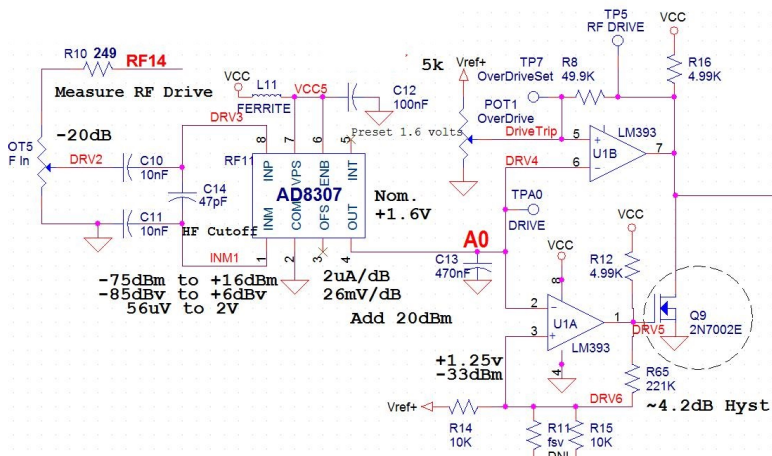
The hysteresis was causing about a 2.5dB jump in the measured voltage at threshold. This was confusing, both real time and in the logged data.

The relay contacts are break-before-make, so during transition there is a brief spike in the (unloaded) RF voltage. When **reducing** the level, that spike retriggered the discriminator, causing a relay chatter. C13 was increased to slow down the response and the hysteresis was increased by changing R65.

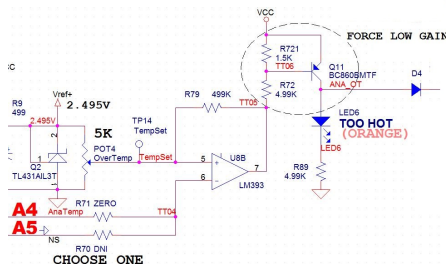
Fig. 2. The temperature channel trip had the same hysteresis problem.

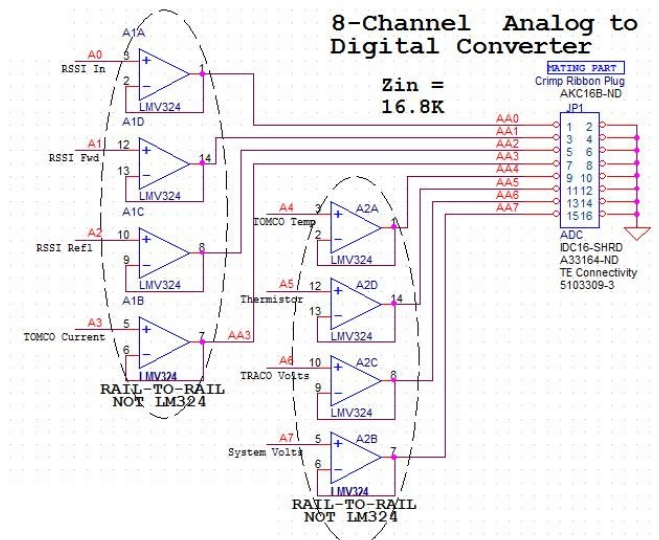
Fig. 5. The Raspberry Pi Analog Board 16.8K inputs would load the RSSI signals, so two LMV324 quad **rail-to-rail** buffers were added. (Note that the LM324 is NOT suitable.)

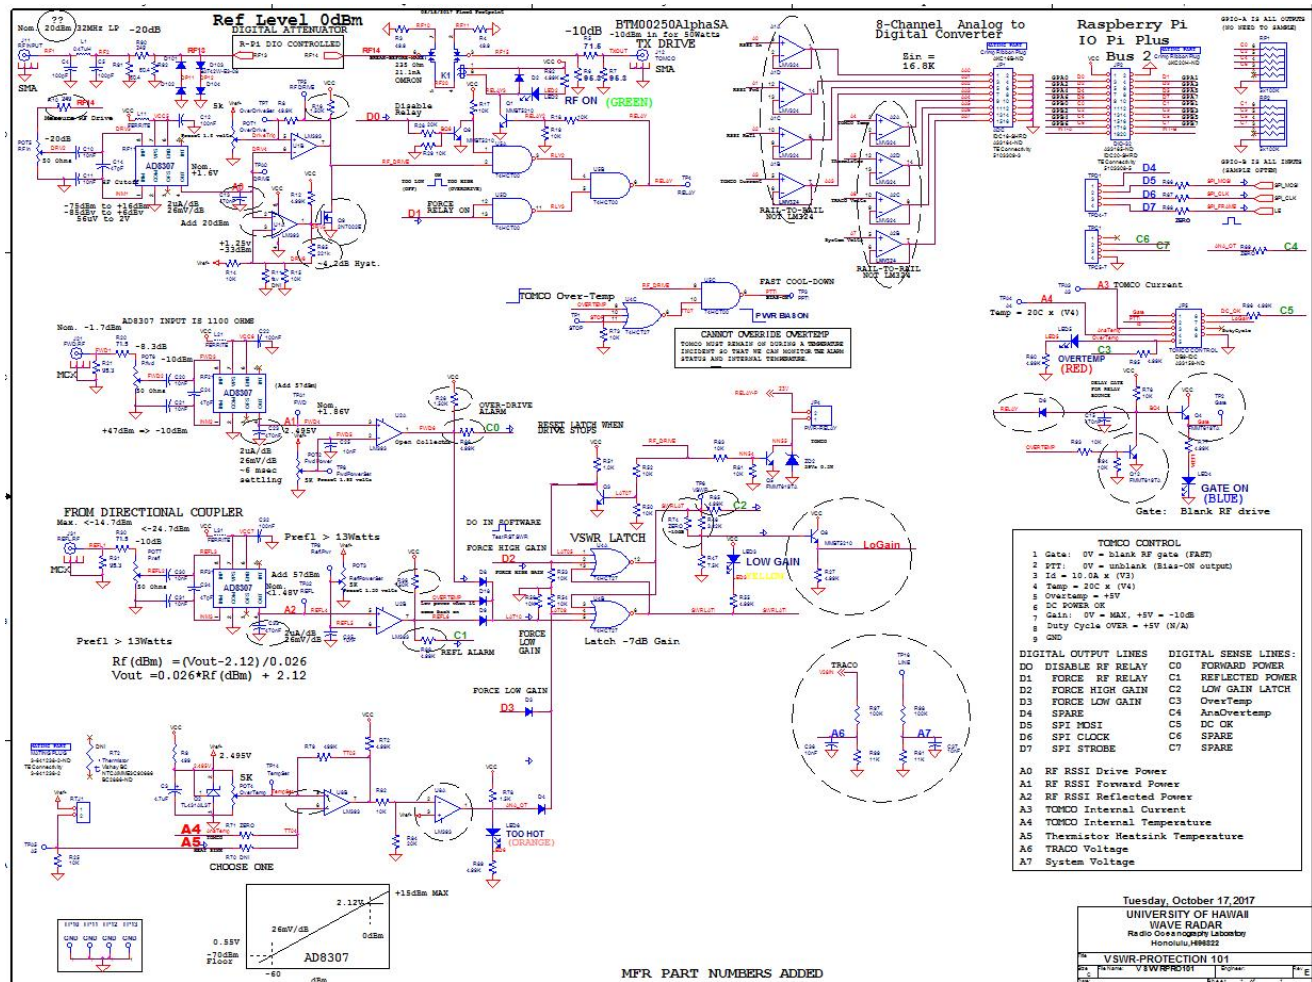
Fig. 8. The Complete schematic. Circuit changes are circled.

Fig. 9. Completed PCB layout. Annular Ring errors corrected.

**No room for a Micro-USB facing down mechanically. Moved to the side. ==>>>**  
Mounting holes are locked (same position as before). Board expanded 0.5" to the right.

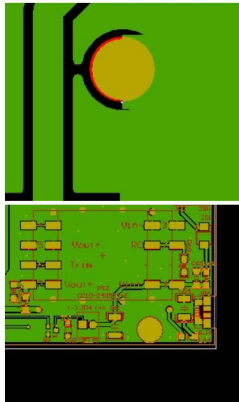
The computer did not understand the context. It simply interprets strict rules.

The DC-DC converter module has ground pins on the metal shield.

These are not assigned pin numbers in the library model so the netlist does not ground them.

I "illegally" placed fills on the board to ground there pins. That eliminates the "clearance" -- on purpose.

A.C. would automatically "restore" that clearance, so I have to OK this "non-error".

Undersized soldermask clearance of 1.95 mils on layer vswpr8dh.GTS, at X=2.713", Y=3.425975".

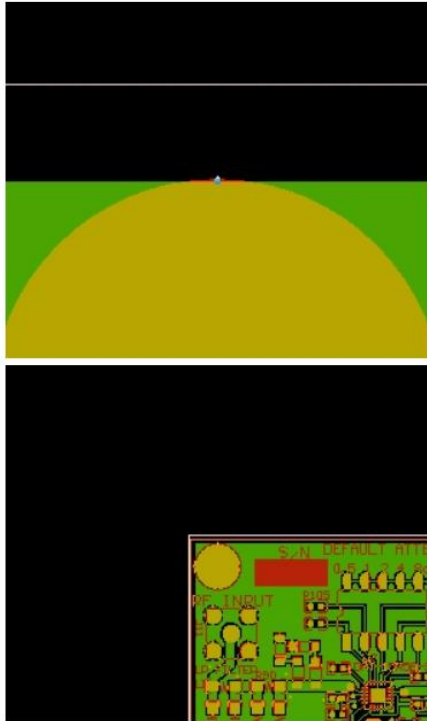
The four mounting holes are indeed grounded in the netlist, but on the PCB there are just four thin Thermal Relief traces on each. For a solid ground, I place a fill patch. This is intentional, not an error. This accounts for four "potential errors".
