## Tech: Testing VSWR Pro Mods

### Modifications to the VSWR Protection Board

Edited 11/04/2017 1:30pm

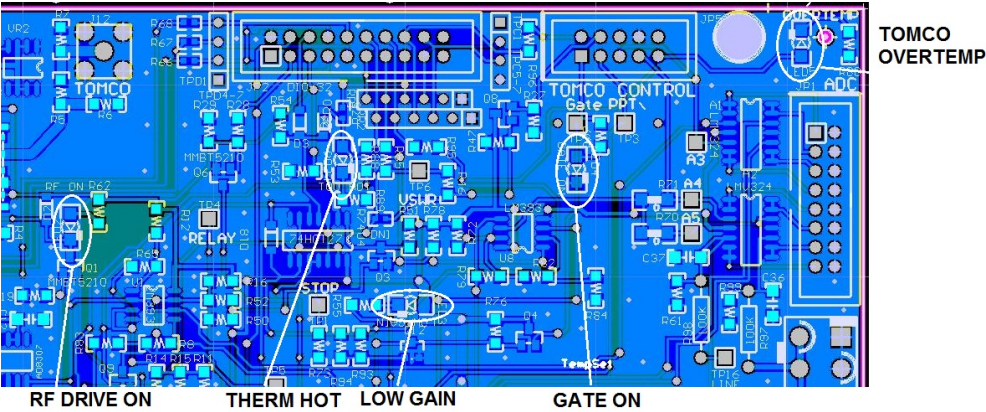
LED Status Indicators

VSWR Protection Status							
	LED2 GREEN RF RELAY	LED3 YELLOW LOW GAIN	LED4 BLUE GATE ON	LED5 RED HOT	LED6 ORANGE HeatSink	ARM Indications	Comment
1	IDLE	OFF	OFF	OFF			
2	RF DRIVE ON	ON	ON			A0 OK	
3	RF Overdrive					A0 High	Not Latched
4	VSWR fault	ON	=>ON	ON		A2 High	Low Power -7 to -10 dB
5	FWD Power Fault	ON	=>ON	ON		A1 High	Low Power -7 to -10 dB
6	TOMCO TEMP Flag	ON	=>ON		ON	A4 TOMCO Internal Temp	Power stage bias off
7	Heatsink Thermistor	ON	=>ON	ON		A5 Heatsink Temperature	
8	RF Drive Off	OFF	Reset	OFF			
		Latched				A3 TOMCO Internal Current
